INSPECTION REPORT

For the Property at:
334 TWINING FLATS ROAD
ASPEN, CO 81611

Prepared for: JON DEUTSER
Inspection Date: Monday, June 17, 2024
Prepared by: David Kline

Report No. 1906

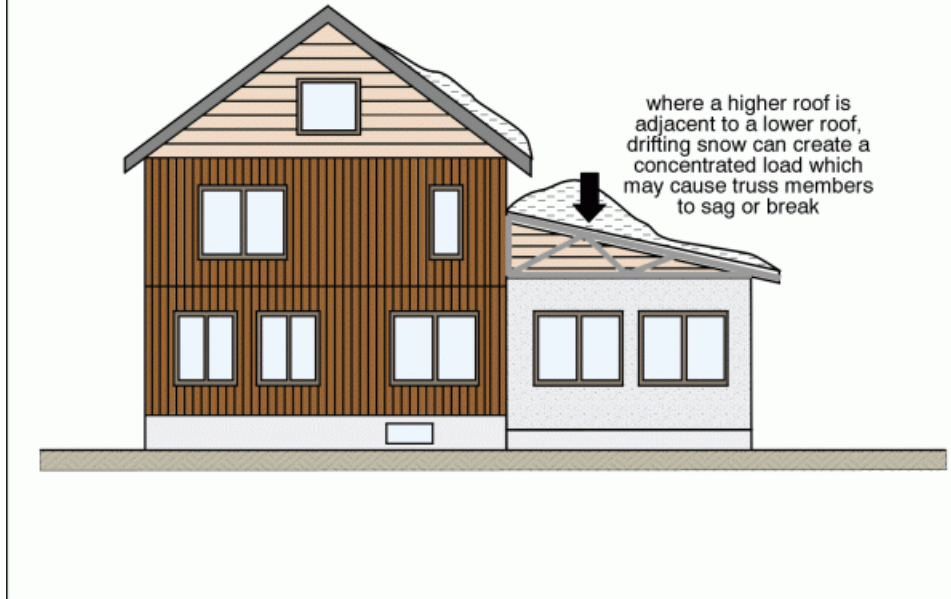
1. Condition: • The amount of snow in this location can cause damage to roof cladding, gutters, heat tape, and other exterior building components. It is strongly recommended to have an annual (spring) service/inspection on roofing and siding, near roof, to reduce chances of water leaks.

Drifting snow can cause truss sag/damage

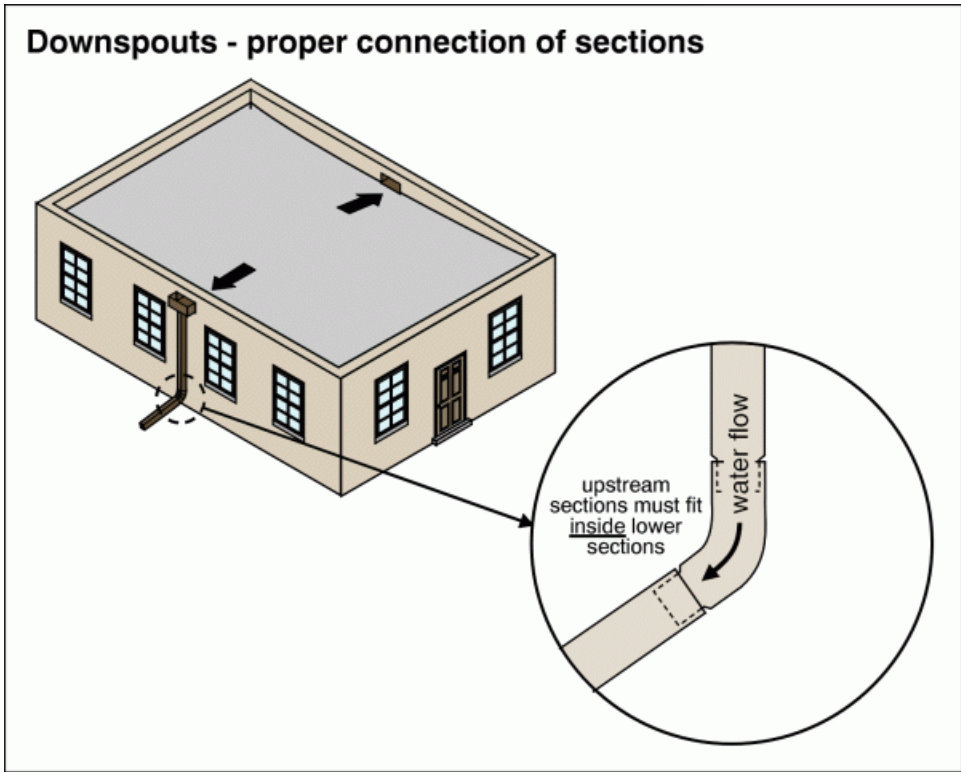
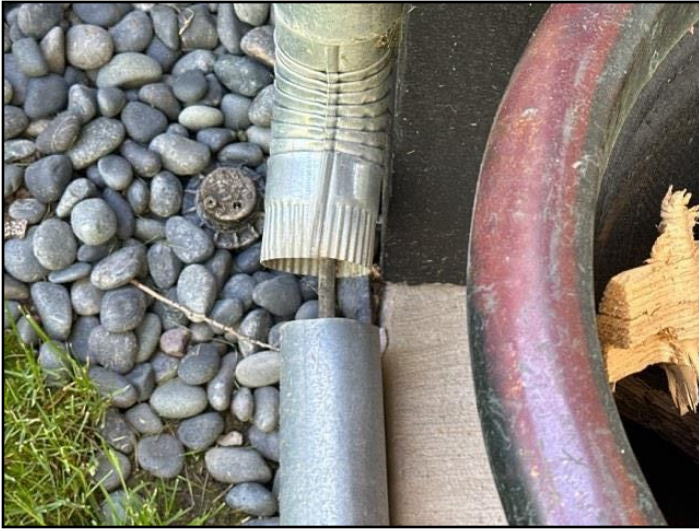
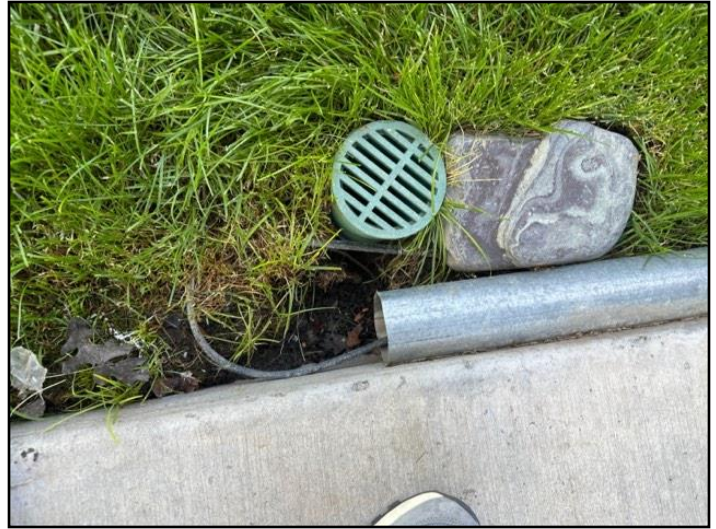
3. Condition: • [Connections loose](#)

Connections loose

Task: Repair

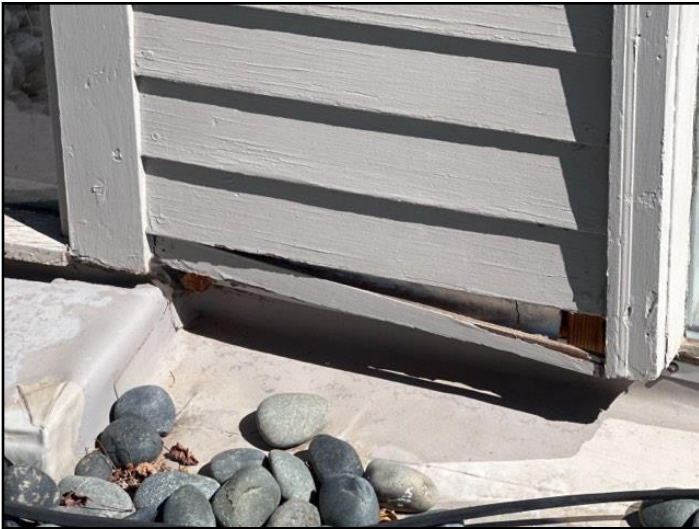
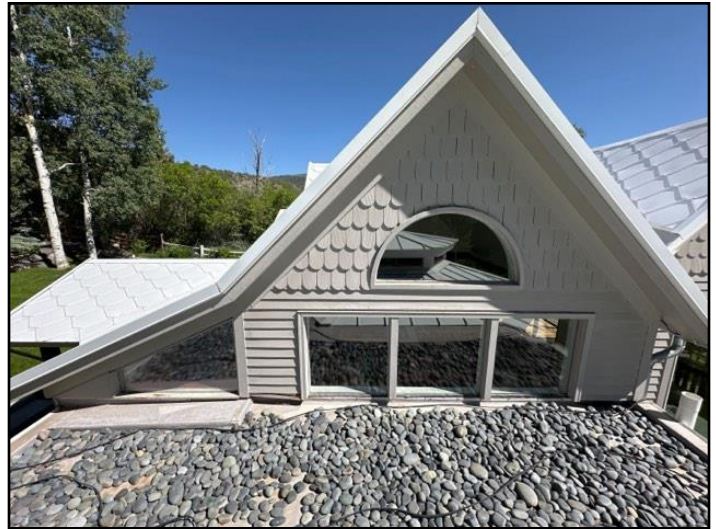
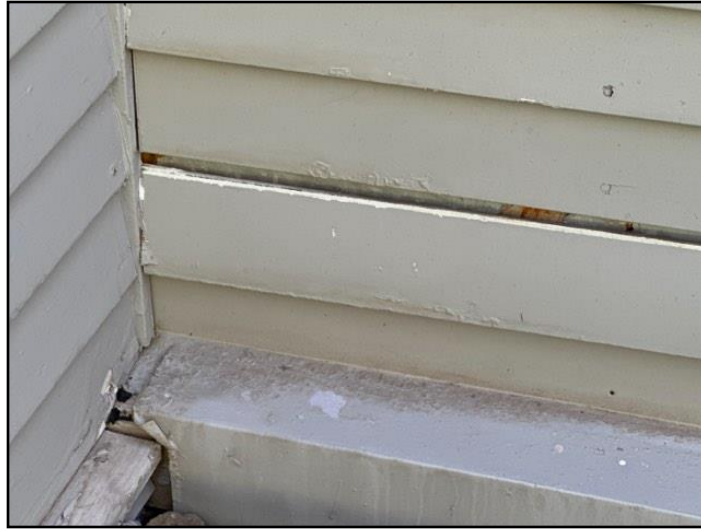
4. Condition: • [Cracked, split or broken](#)

Some of the siding has cupped, split or broken. It is best practice repair/replace broken siding before painting.

Cracked, split or broken

Task: Repair or replace

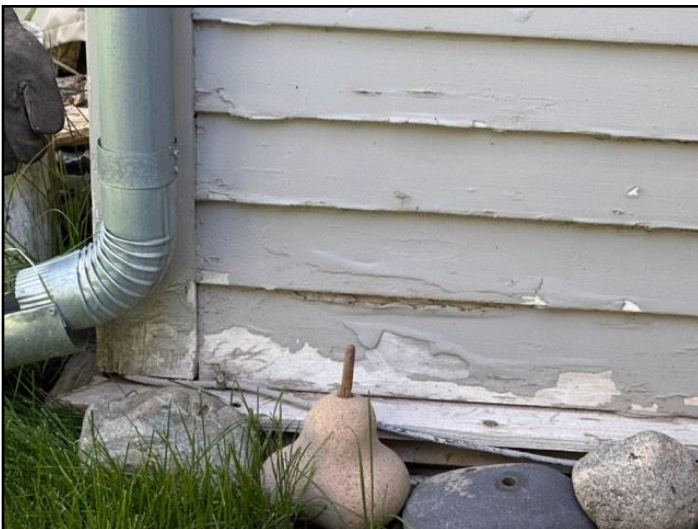
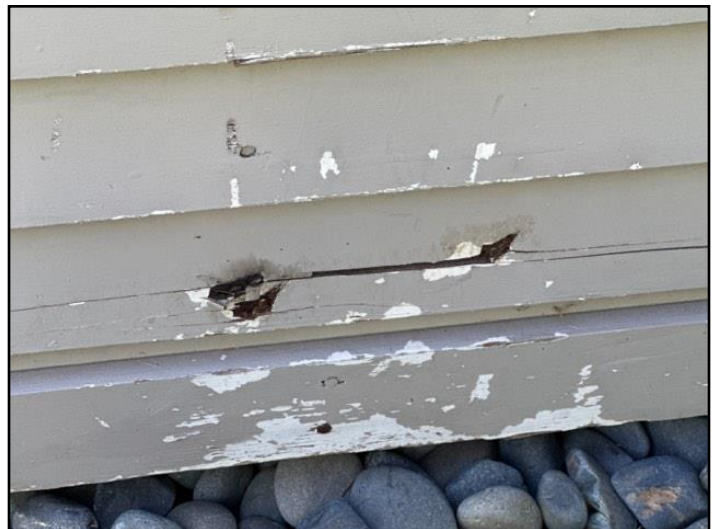
6. Condition: • [Paint or stain - needed](#)

Paint or stain - needed

Task: Repair

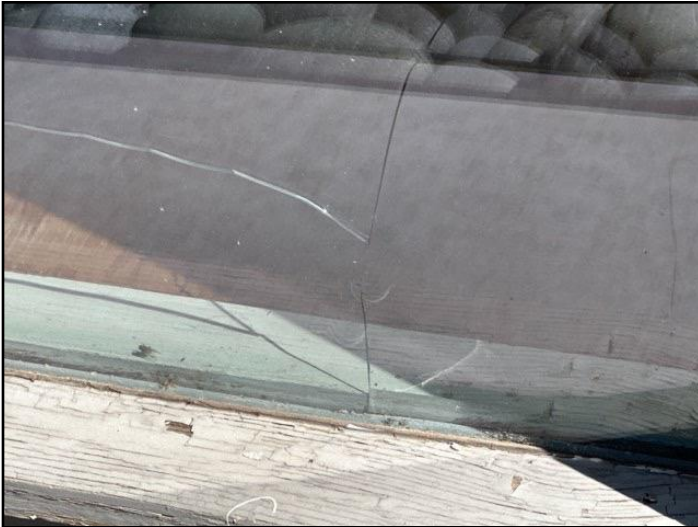
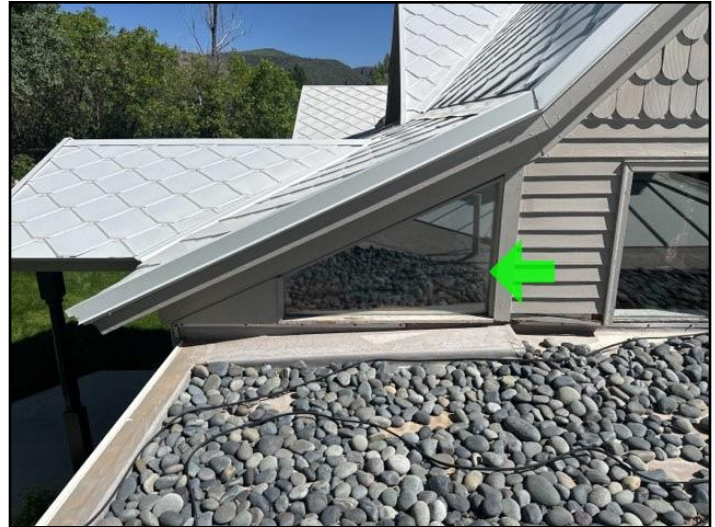
8. Condition: • [Broken](#)

Broken

Task: Replace

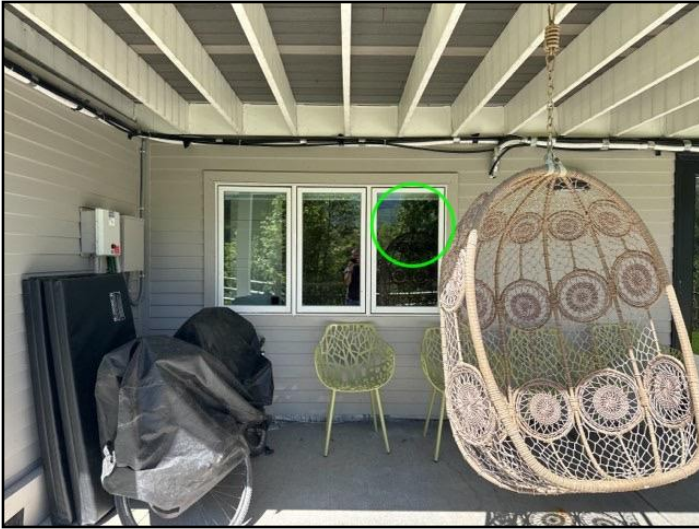
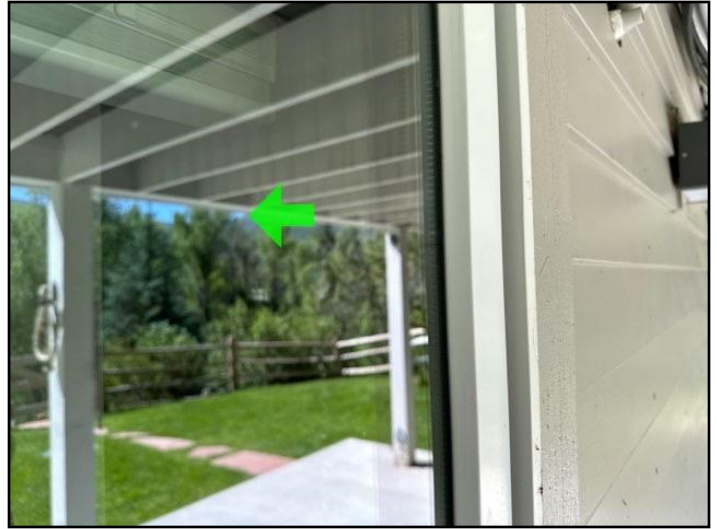
9. Condition: • [Broken](#)

There is a small chip in glass, similar to a rock hitting a windshield type of chip.

Broken

Task: Repair or replace

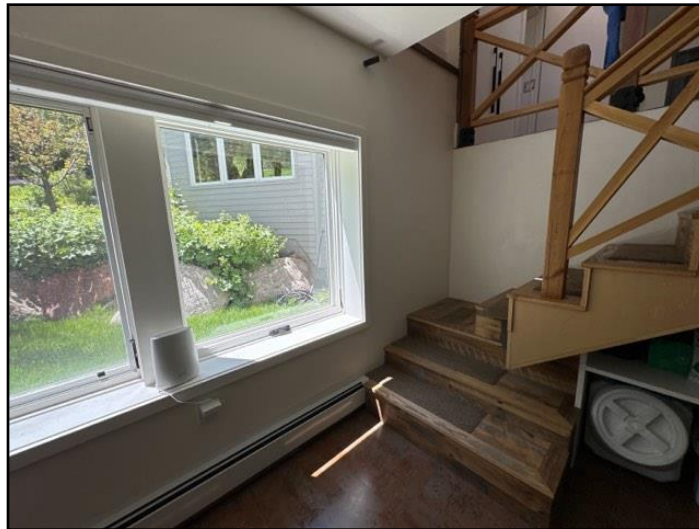
10. Condition: • Safety glass not installed

Tempered glass stamp was not visible on window. Installing tempered glass or safety film should be installed where occupants have an increased chance of slipping/falling, such as stairs and bathtubs. Recommend consulting with contractor.

Safety glass not installed

Task: Improve

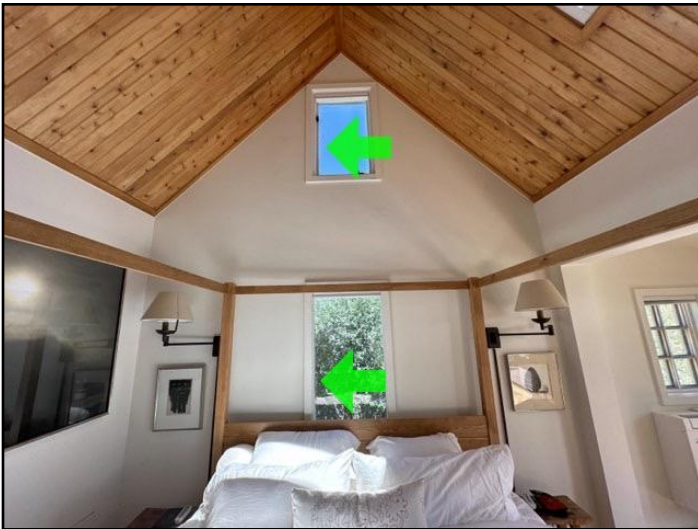
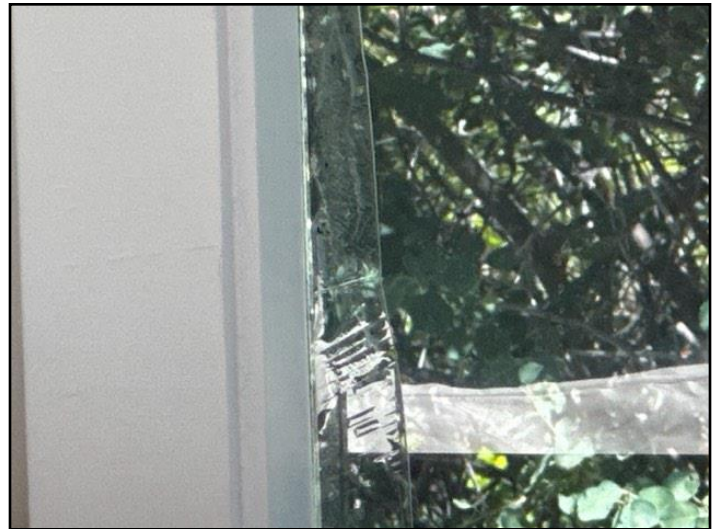
11. Condition: • Damage to tinting.

Damage to tinting.

Task: Repair or replace

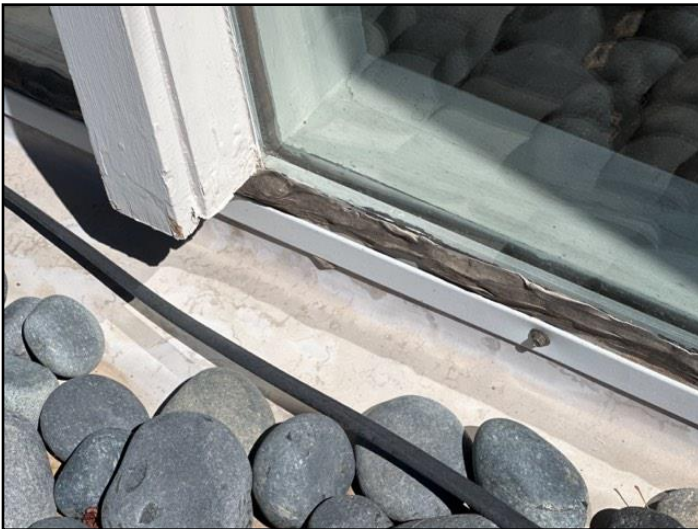
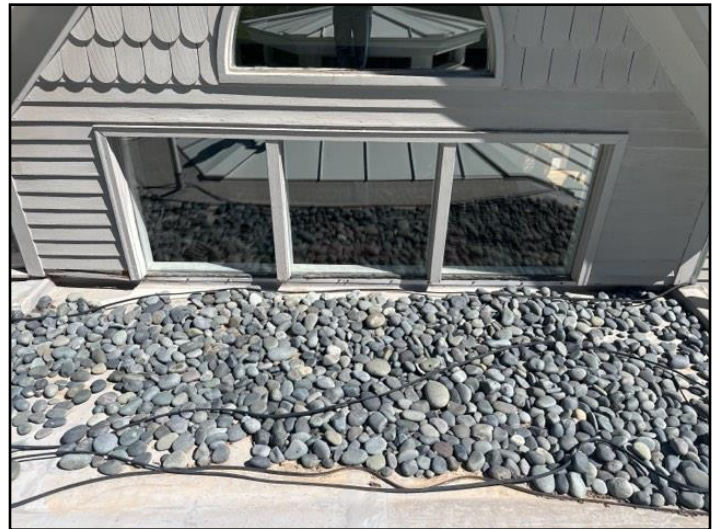
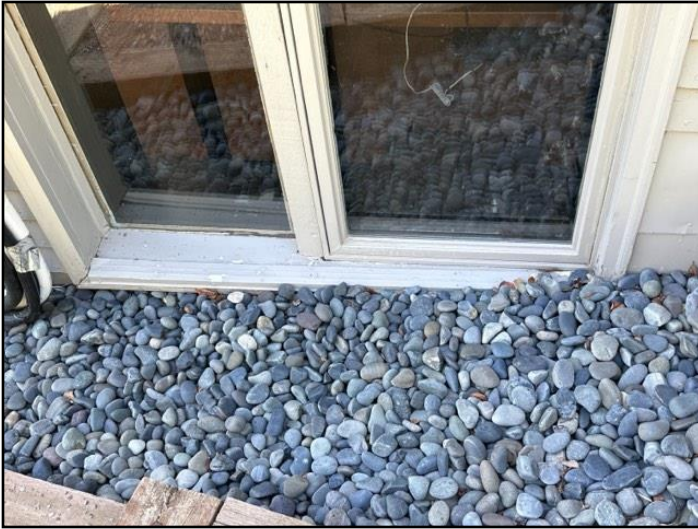
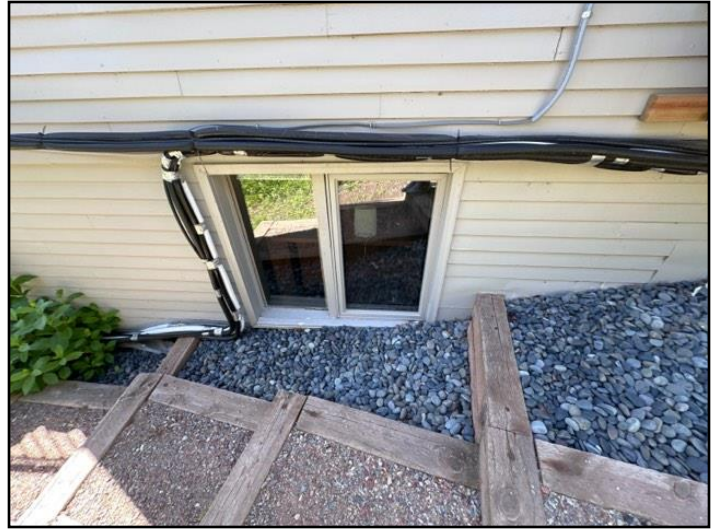
12. Condition: • [Inadequate sill projection](#)

Window is close to grade and has potential for leaks due to snow and irrigation.

Inadequate sill projection

Task: Improve

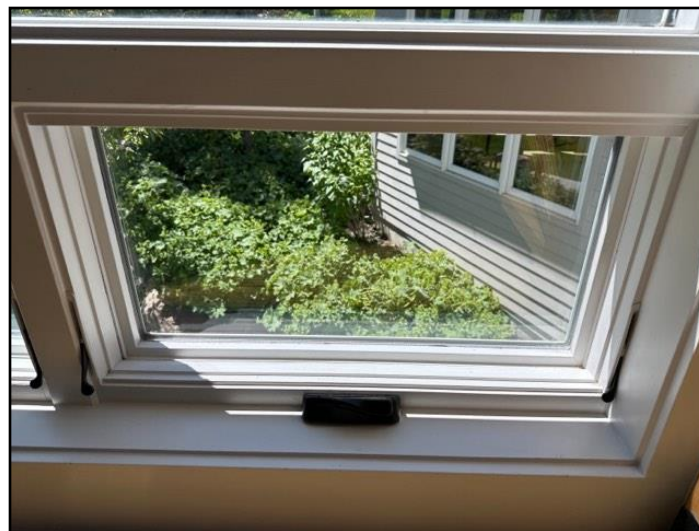
13. Condition: • [Missing](#)

Missing

Task: Provide

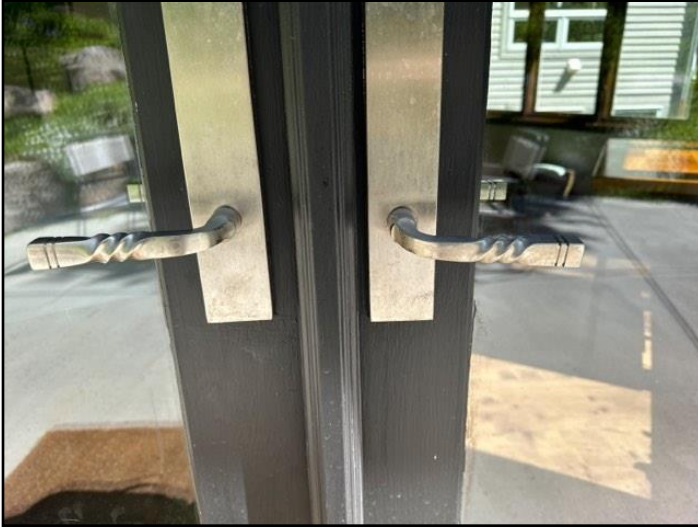
14. Condition: • [Many of the first floor doors have lever type handles. In areas where bears live it is strongly advised to have round exterior exterior door knobs/handles.](#)

Many of the first floor doors have lever...

Task: Replace
Time: Discretionary

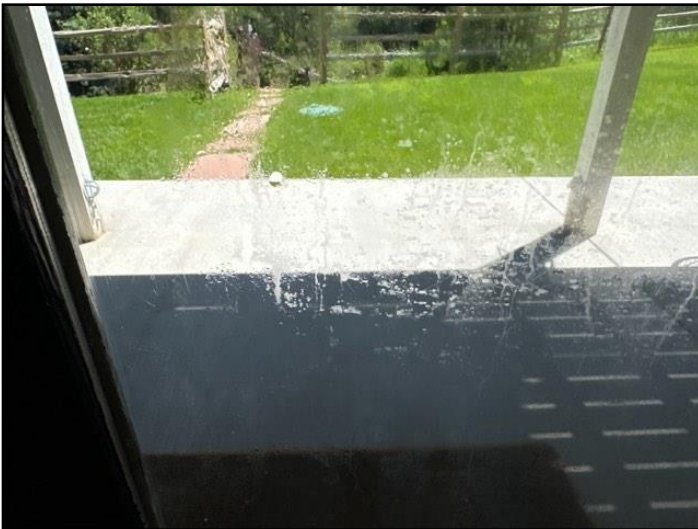
15. **Condition:** • [Lost seal](#)

Lost seal

Task: Repair or replace

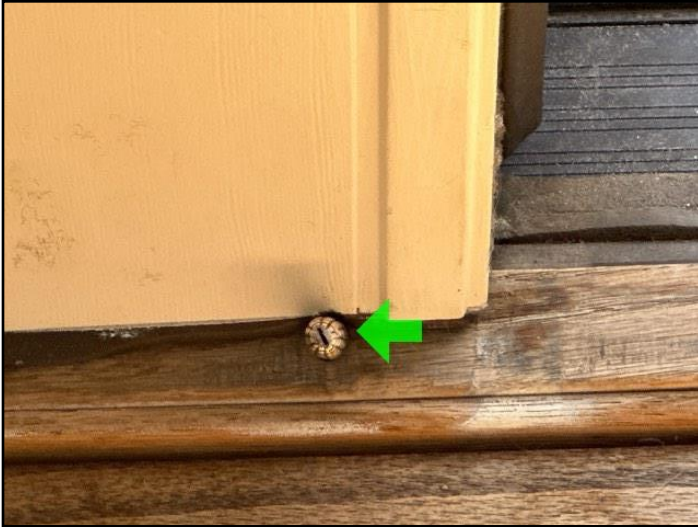
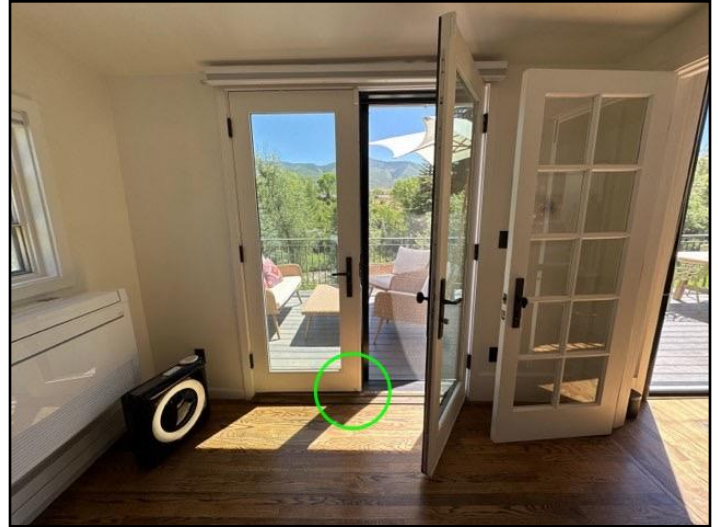
16. **Condition:** • Missing or damaged

Missing or damaged

Task: Repair

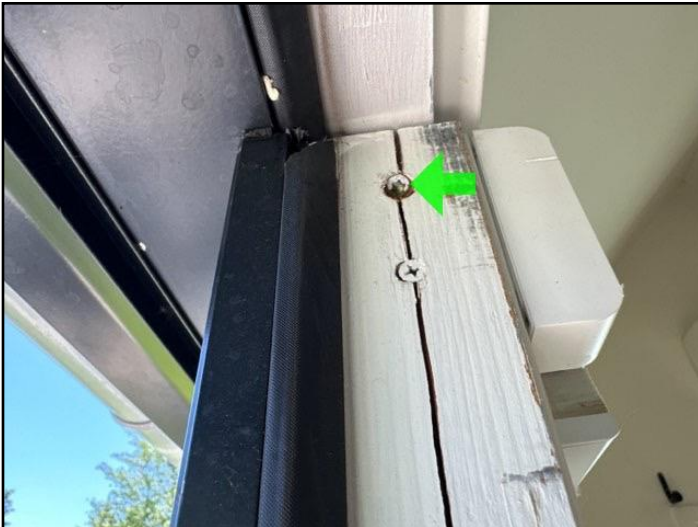
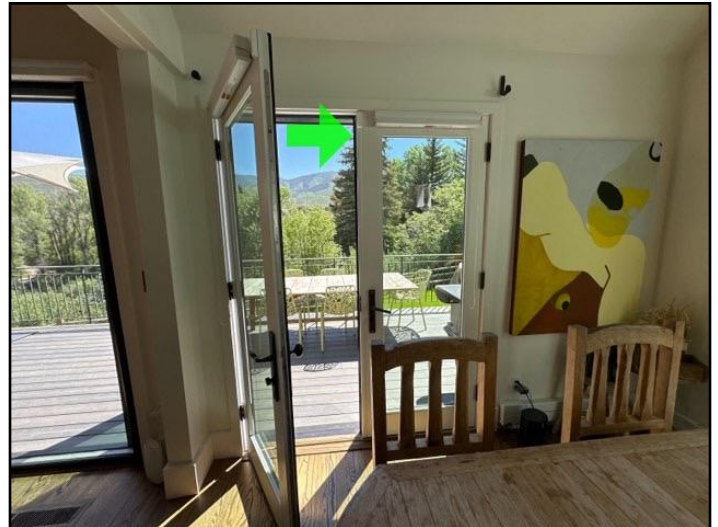
17. Condition: • Missing or damaged
Inactive is screwed closed.

Missing or damaged

Task: Repair

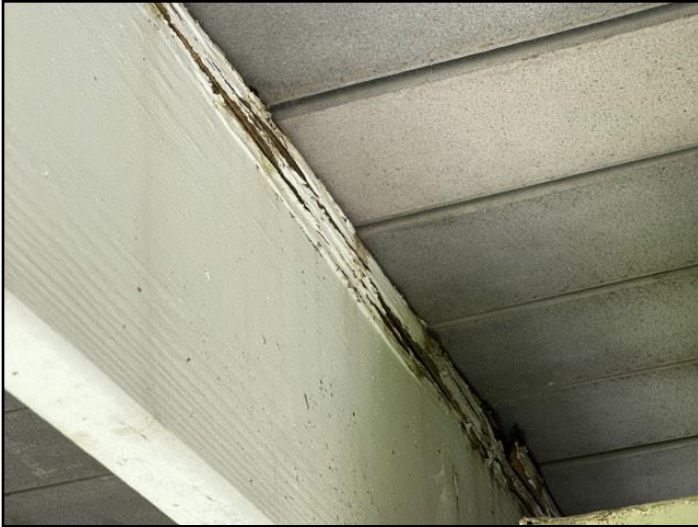
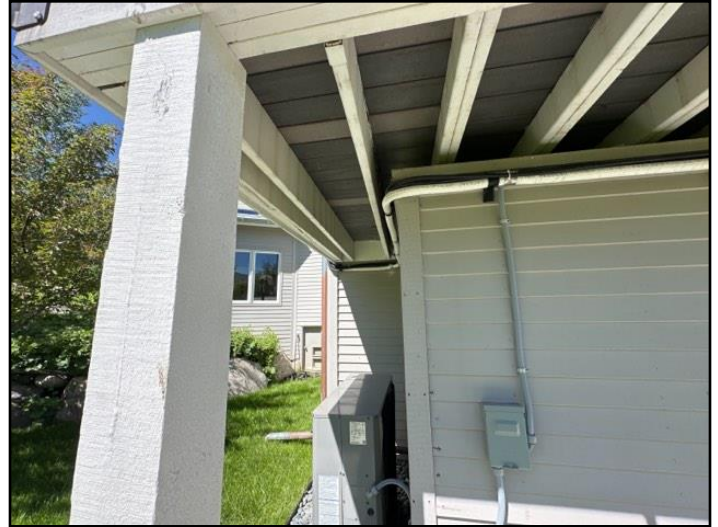
18. Condition: • [Rot](#)

Rot

Task: Repair or replace

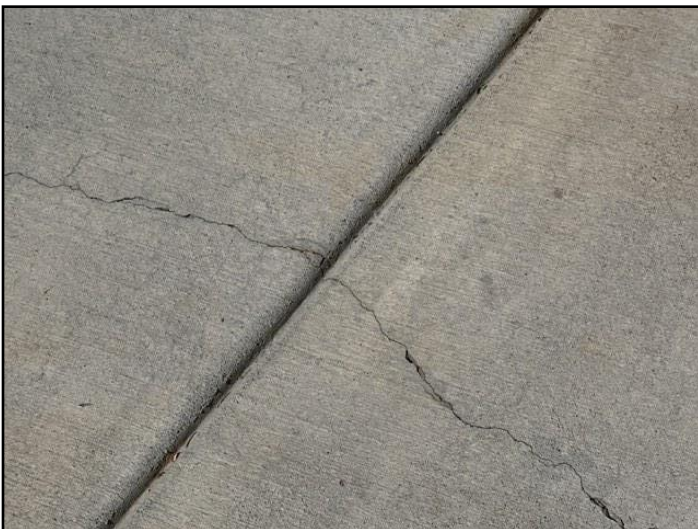
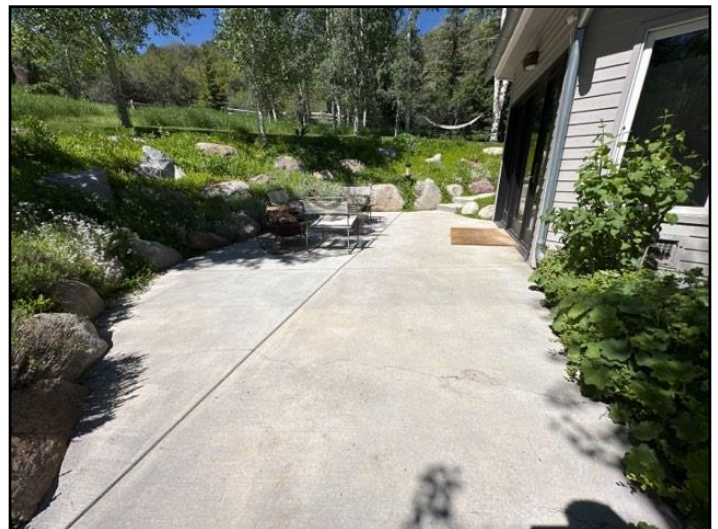
19. Condition: • [Cracked or damaged surfaces](#)

It is typical for concrete to crack. If cracks increase in size or elevation changes recommend repair.

Cracked or damaged surfaces

Task: Monitor

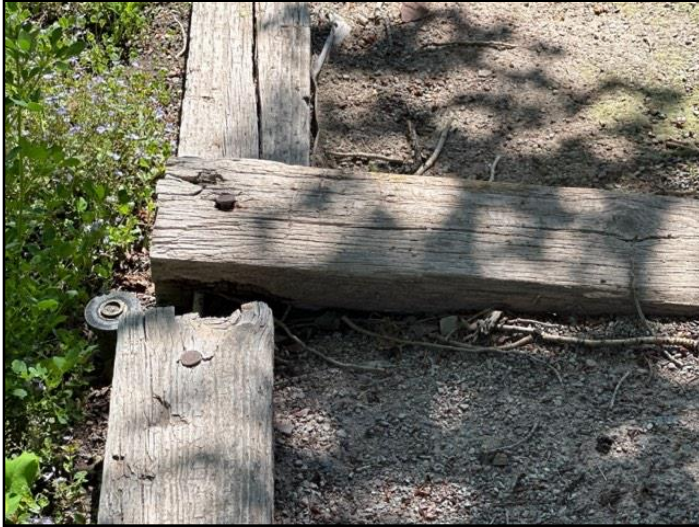
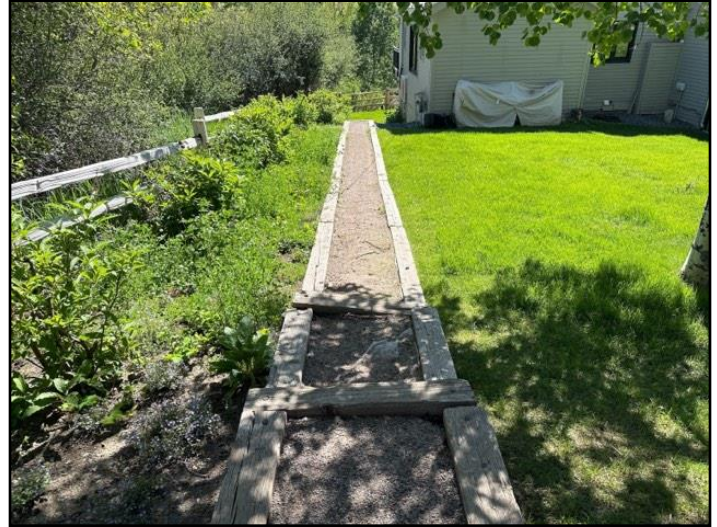
20. Condition: • Uneven (trip hazard)

Uneven (trip hazard)

Task: Improve

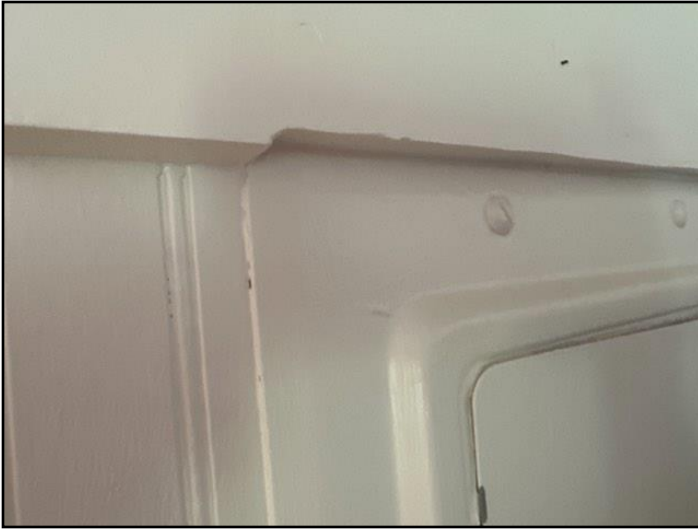
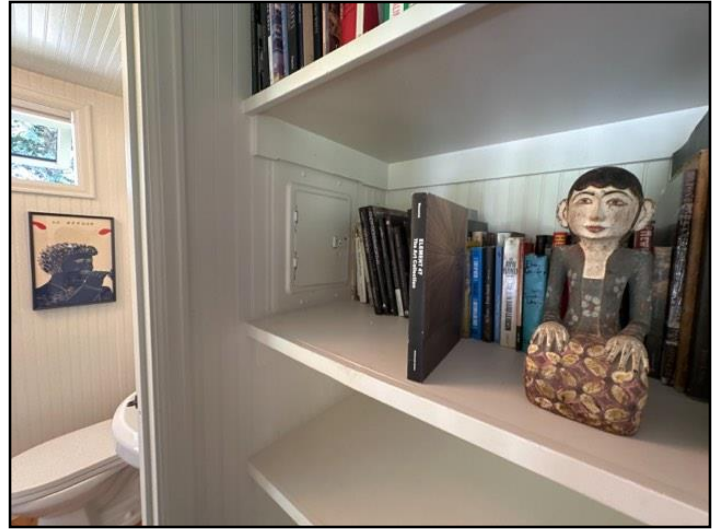
Panel is painted/caulked to wall. Removing...

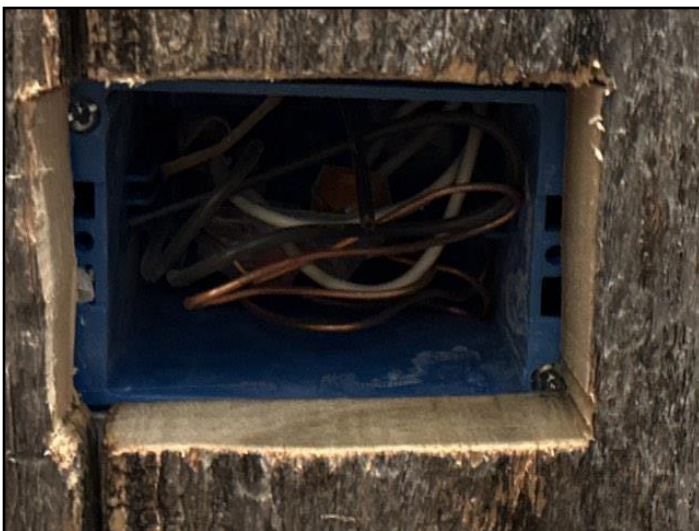
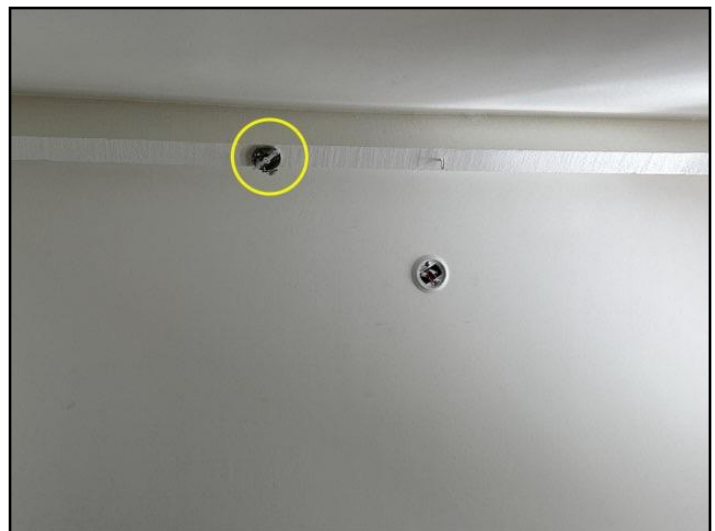
24. Condition: • Damaged, loose or missing

Damaged, loose or missing

Task: Repair

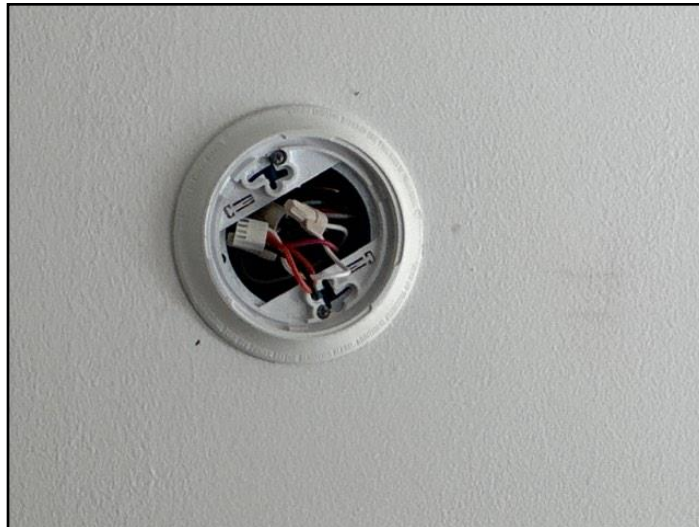
25. Condition: • Missing

Missing

Task: Replace

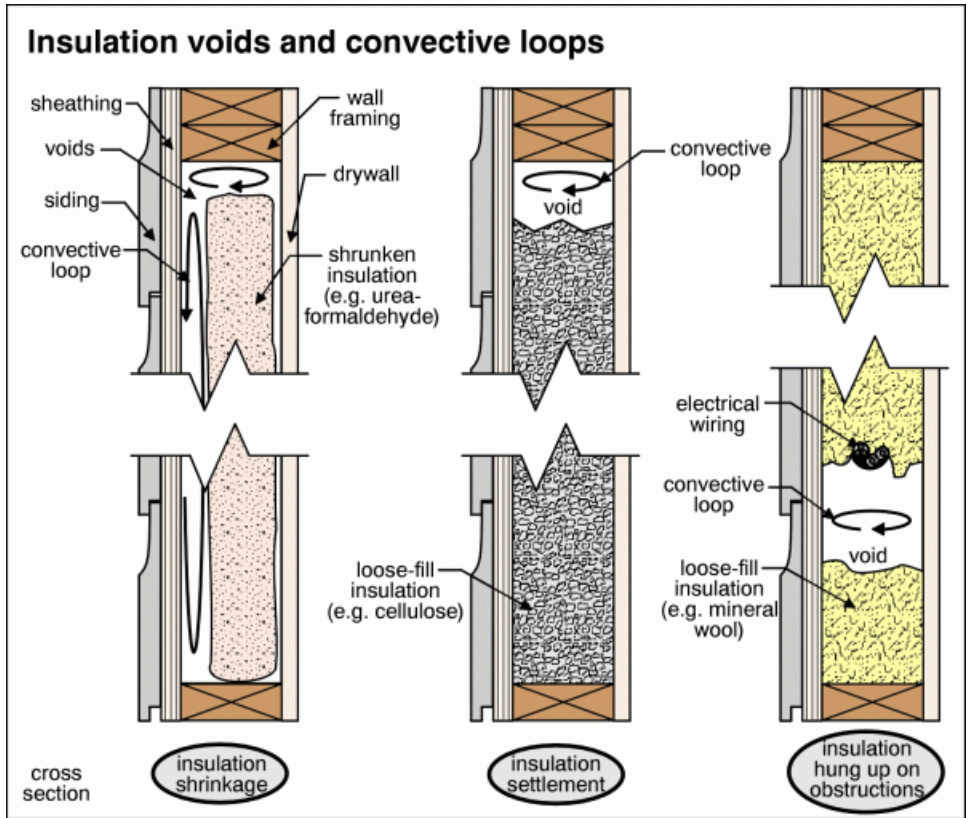
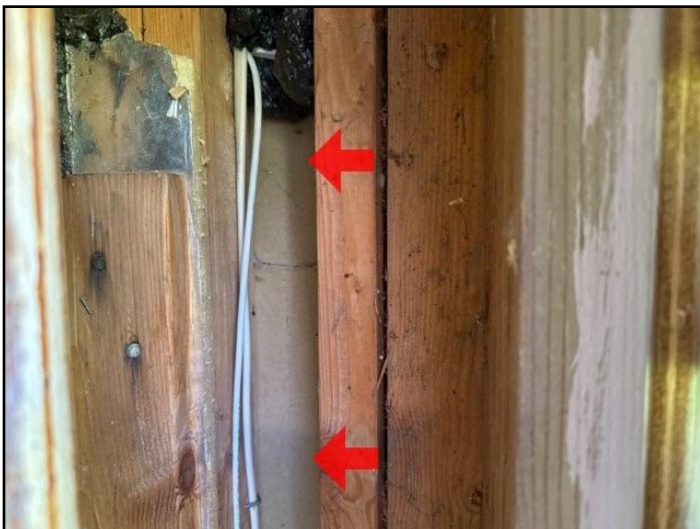
WALLS \ Insulation
31. Condition: • [Sagging or voids](#)
Implication(s): Increased heating and cooling costs | Reduced comfort
Location: West Exterior Wall
Task: Repair
Time: As soon as practical

Voids

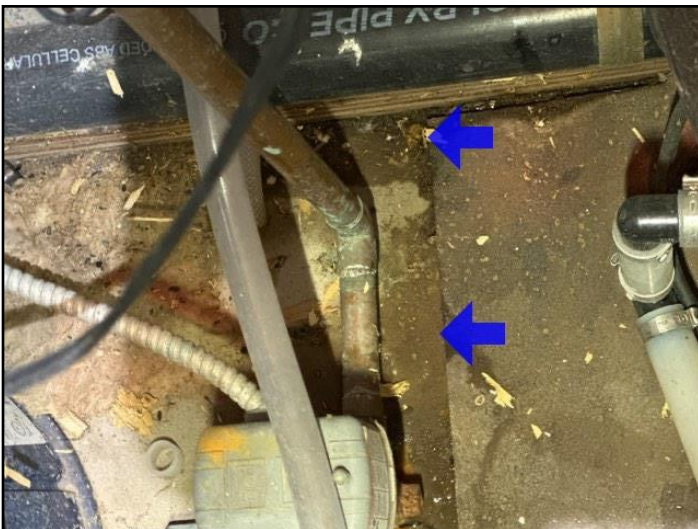
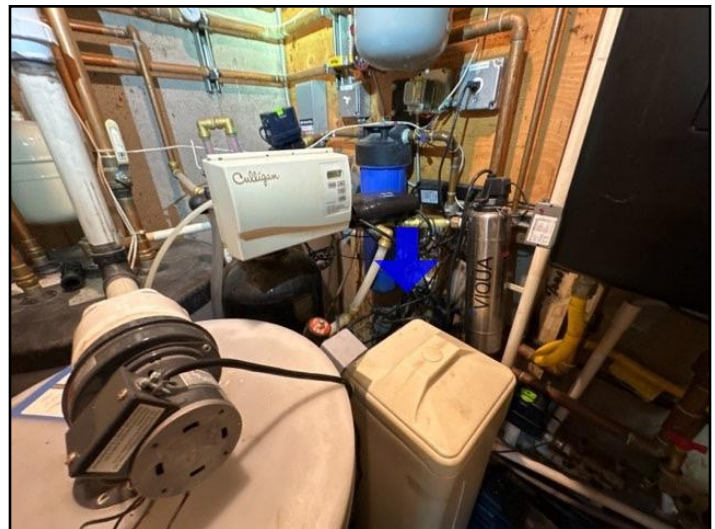
33. Condition: • [Leak](#)

There was water on the floor indicating a slow leak. Exact location/source of leak was not found.

Leak

Task: Repair

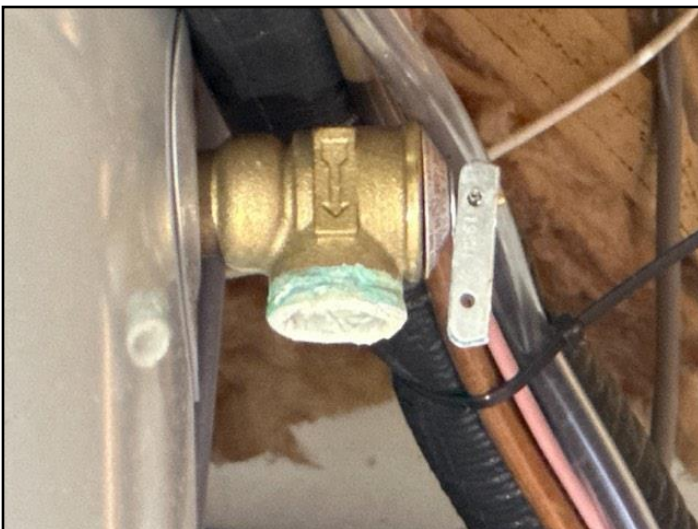
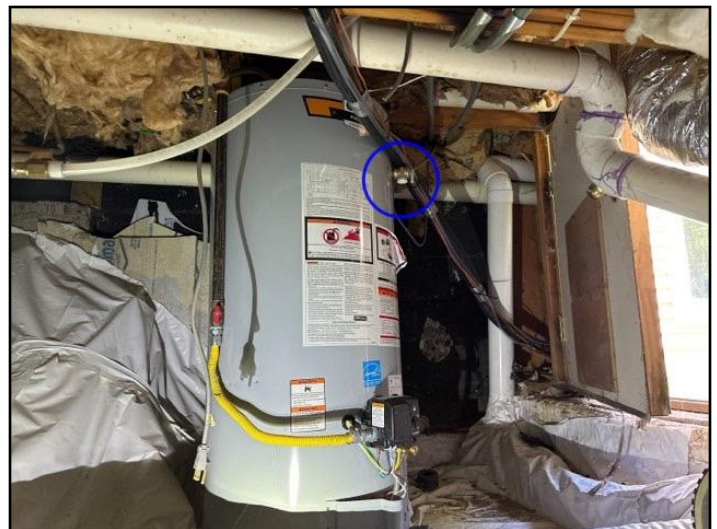
34. Condition: • [Discharge tube missing](#)

Discharge tube missing

Implication(s): Scalding
Location: Crawl Space
Task: Repair
Time: As soon as practical

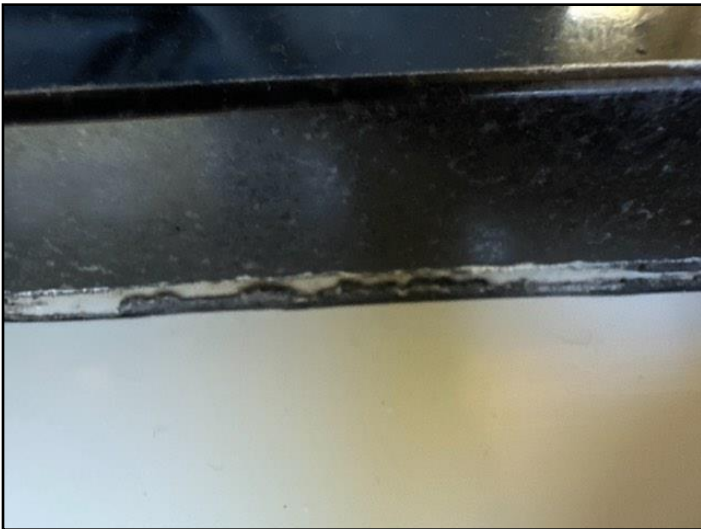
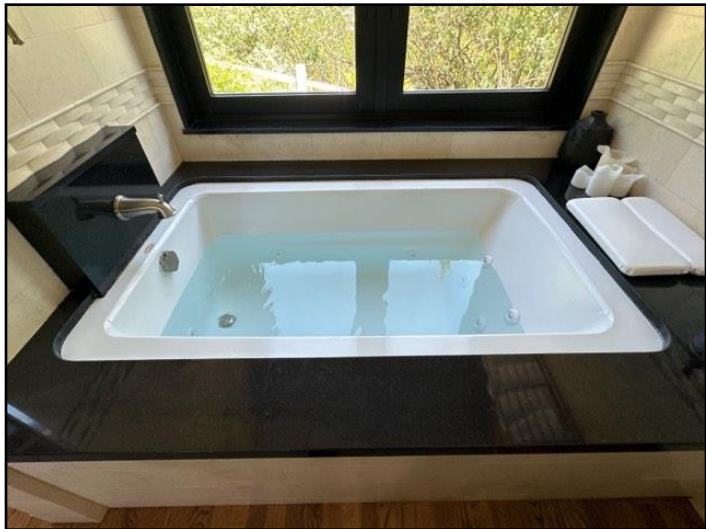
37. Condition: • [Caulking loose, missing or deteriorated](#)

Caulking loose, missing or deteriorated

Task: Repair

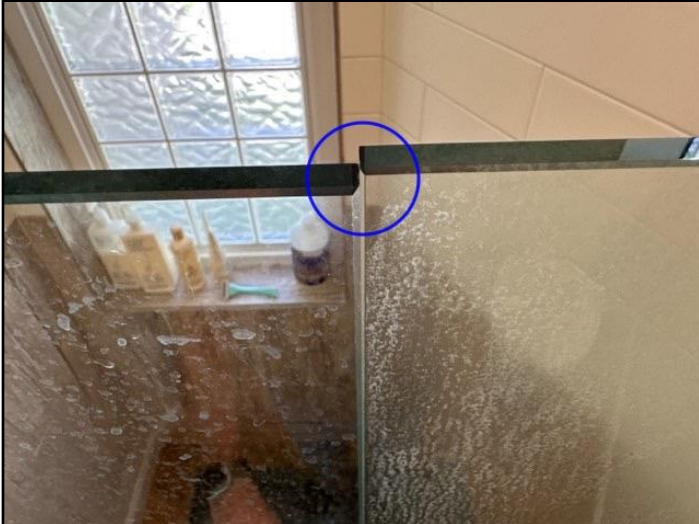
38. Condition: • [Entrance problems](#)

Entrance problems

Task: Repair

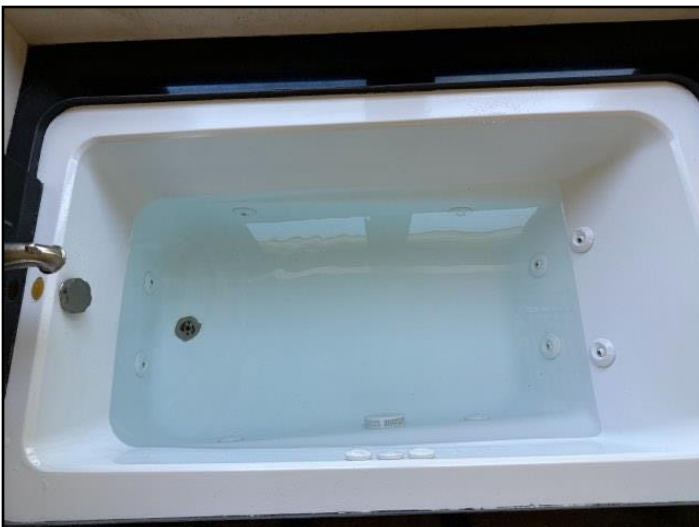
39. Condition: • [Inoperative](#)

Jets did not turn on when button was pressed. Home owner stated tile needs to be removed to repair.

Inoperative

Task: Repair

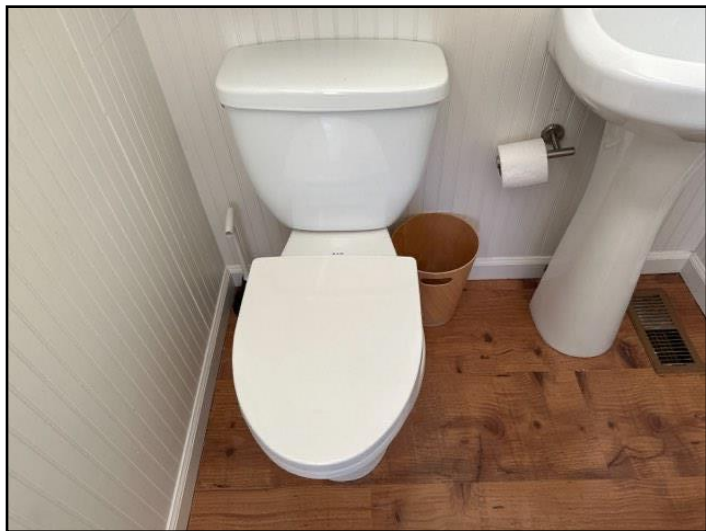
40. Condition: • [Loose](#)

Loose

Task: Repair

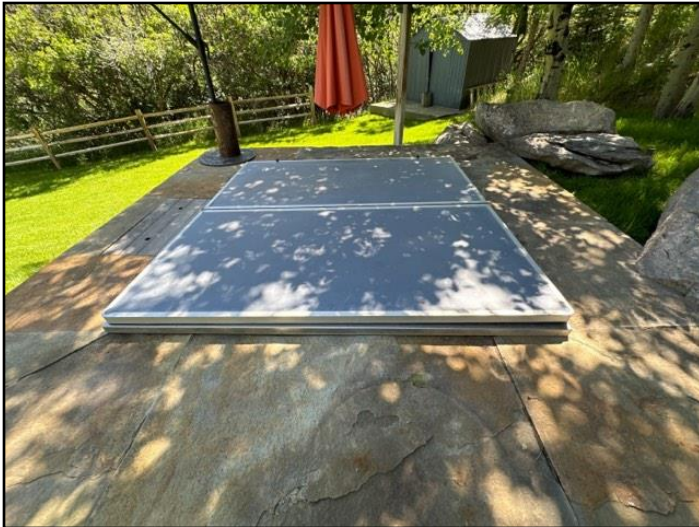
41. Condition: • Swimming Pools, Spas, Hot Tubs and Equipment are discussed in the information that follows. Hot tub was being serviced/repared at time of inspection. Recommend consulting with home owners

Being serviced

Task: Repair

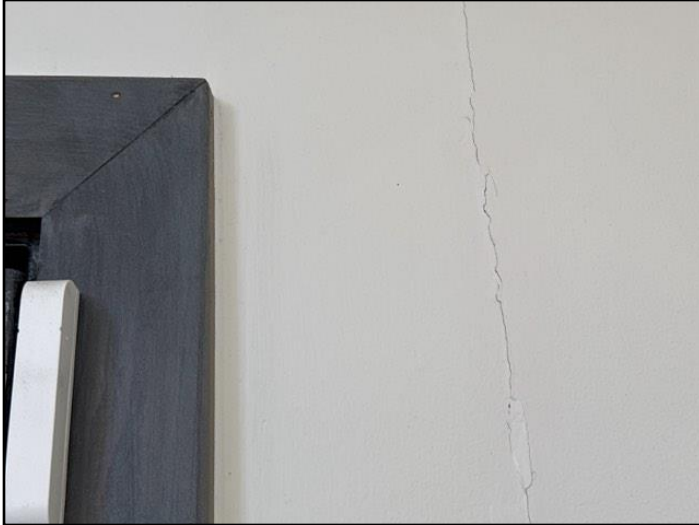
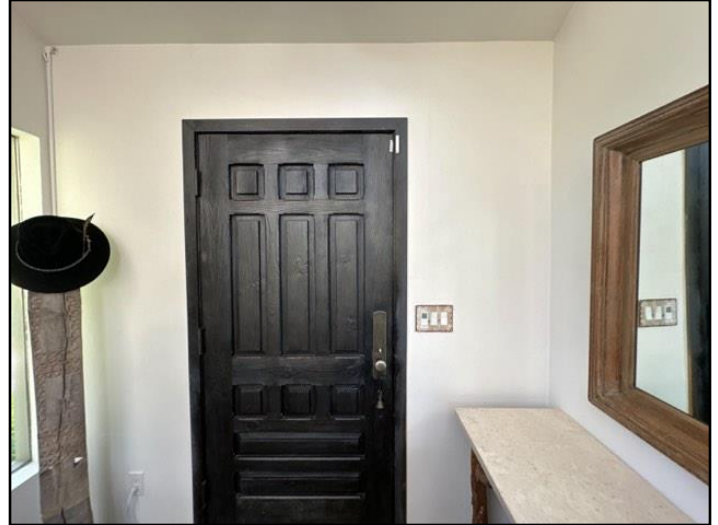
Cracked

Location: Entry
Task: Repair
Time: Discretionary

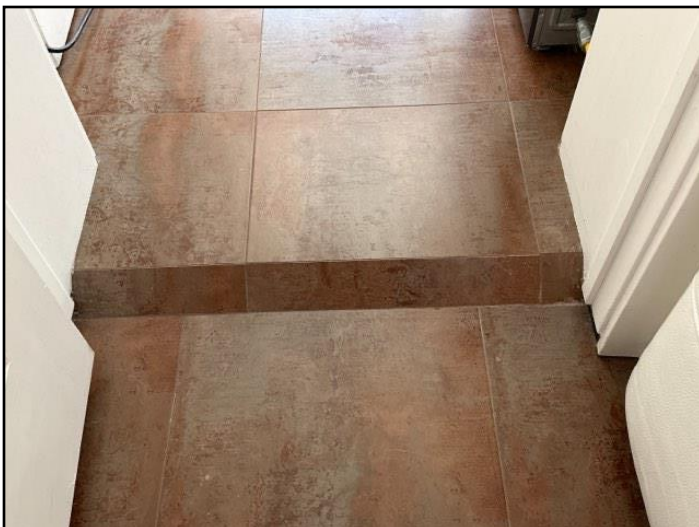
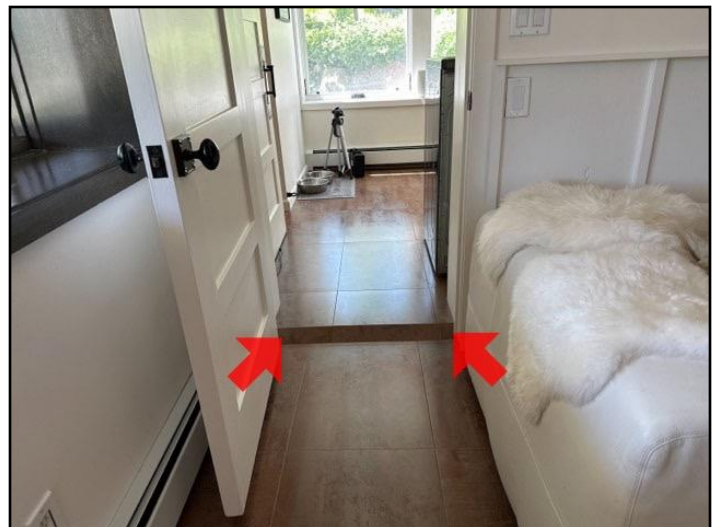
44. Condition: • [Trip hazard](#)

Trip hazard

Task: Improve
