INSPECTION REPORT

For the Property at:
334 TWINING FLATS ROAD
ASPEN, CO 81611

Prepared for: JON DEUTSER
Inspection Date: Monday, June 17, 2024
Prepared by: David Kline

Report No. 1906

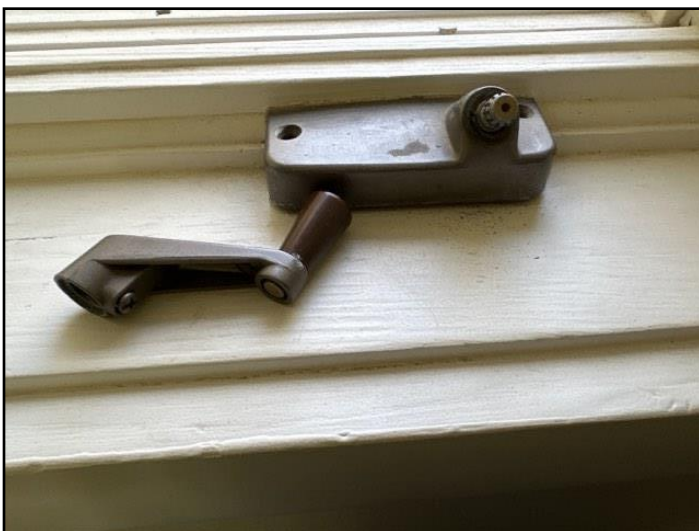
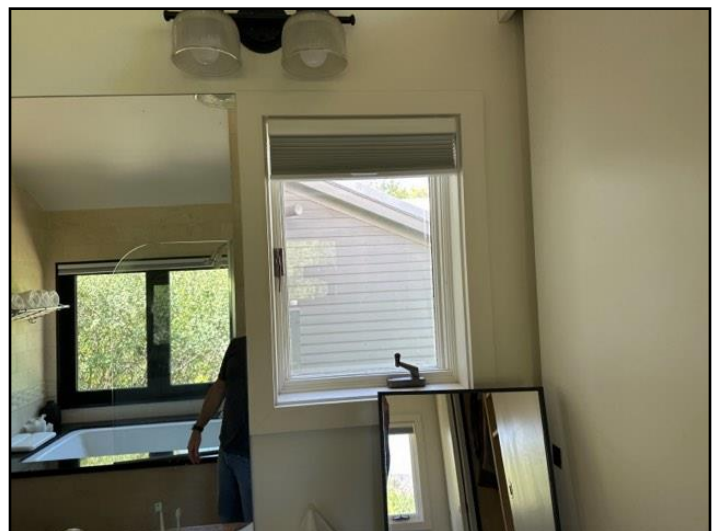
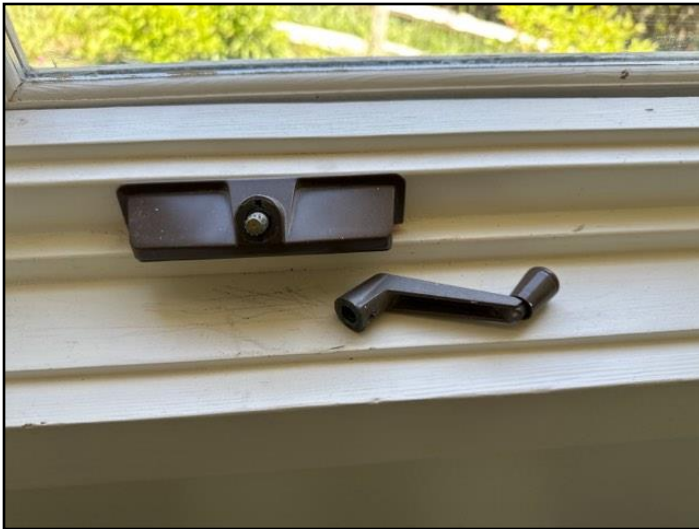
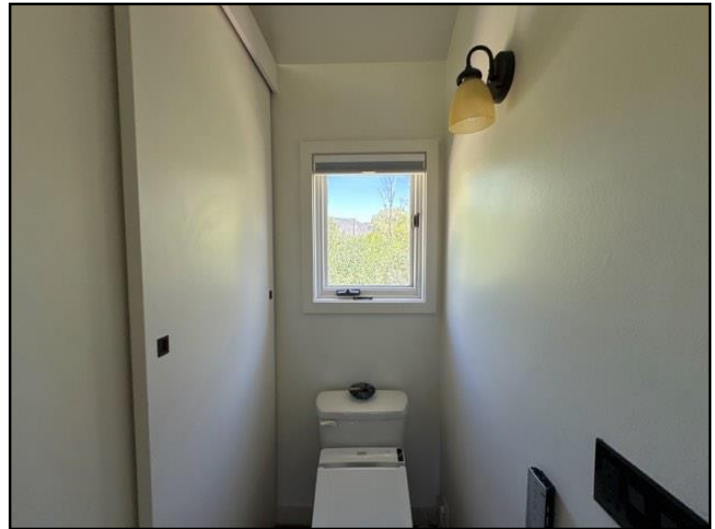
46. Condition: • [Broken](#)

Broken

Task: Repair

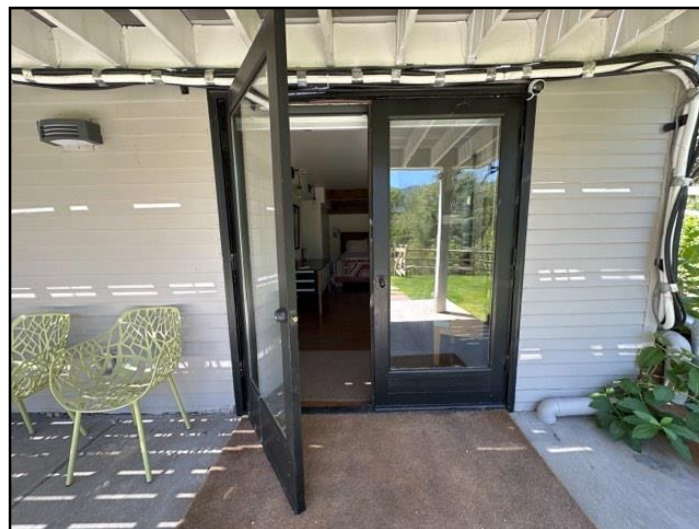
47. Condition: • [Installed backwards](#)

Installed backwards

Task: Improve

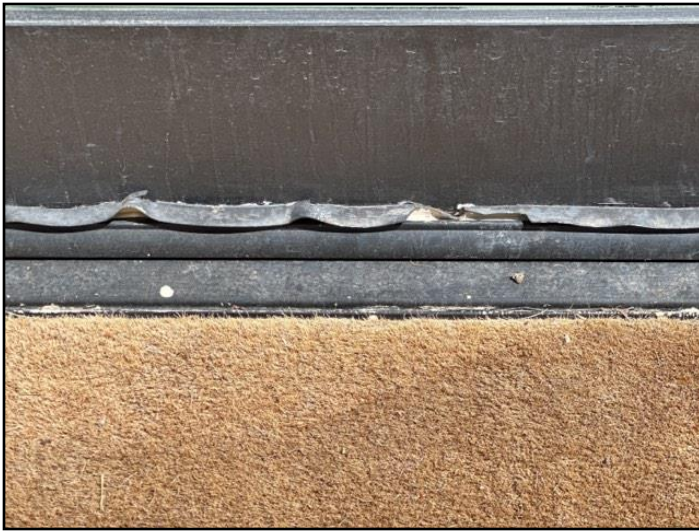
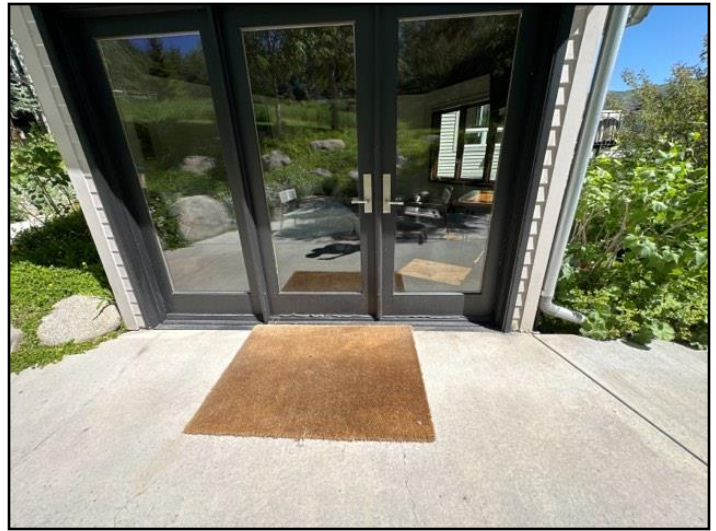
48. Condition: • [Weatherstripping missing or ineffective](#)

Weatherstripping missing or ineffective

Task: Repair
