INSPECTION REPORT

For the Property at:
334 TWINING FLATS ROAD
ASPEN, CO 81611

Prepared for: JON DEUTSER
Inspection Date: Monday, June 17, 2024
Prepared by: David Kline

Report No. 1906

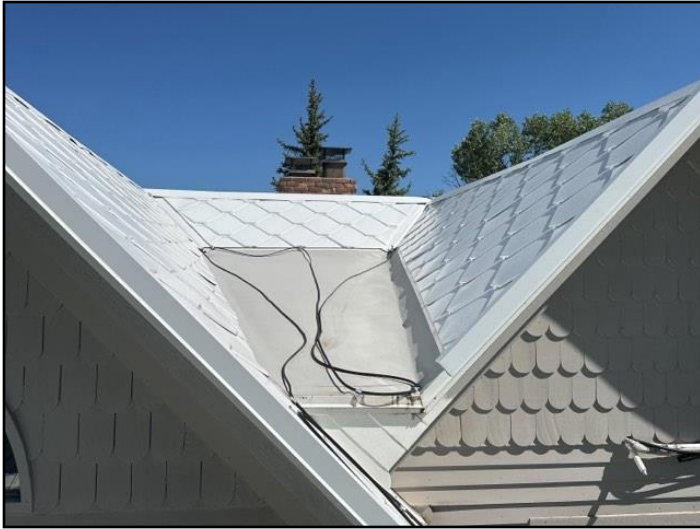
2. Condition: • Vulnerable to ice damming

Vulnerable to ice damming

Operating and maintaining installed heat tape can minimize damage due to ice dams

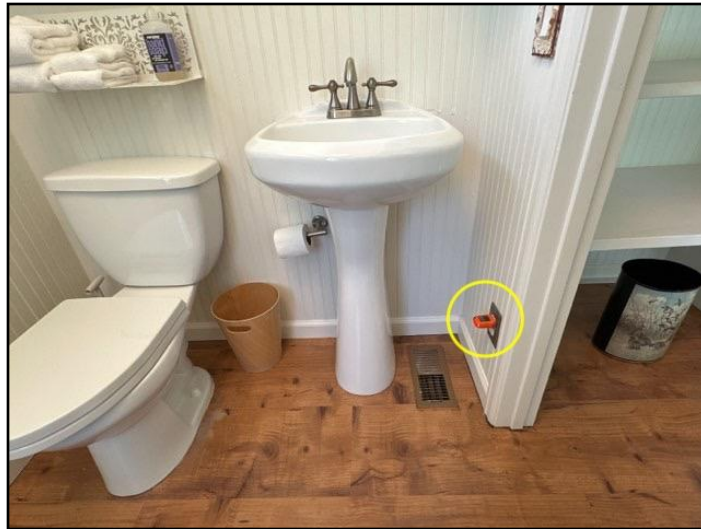
GFCI/GFI needed (Ground Fault Circuit...

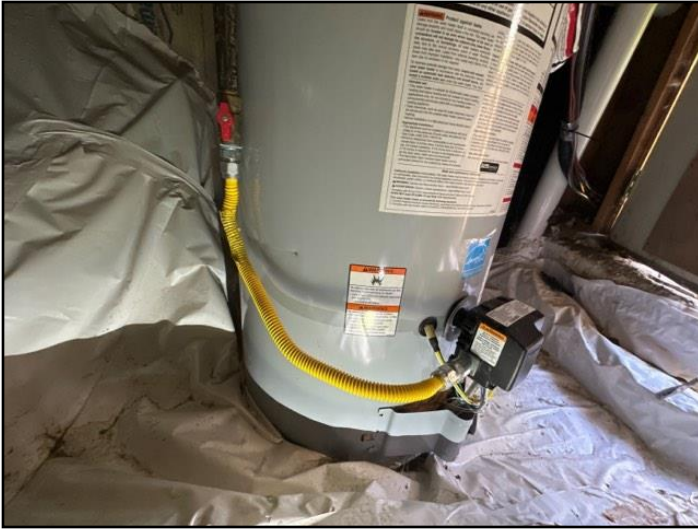
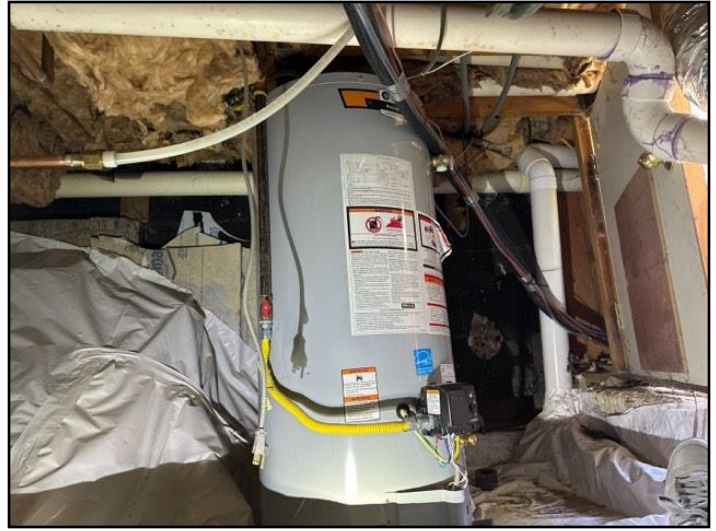
No drip leg (sediment trap, dirt pocket)
