INSPECTION REPORT

For the Property at:
334 TWINING FLATS ROAD
ASPEN, CO 81611

Prepared for: JON DEUTSER
Inspection Date: Monday, June 17, 2024
Prepared by: David Kline

Report No. 1906

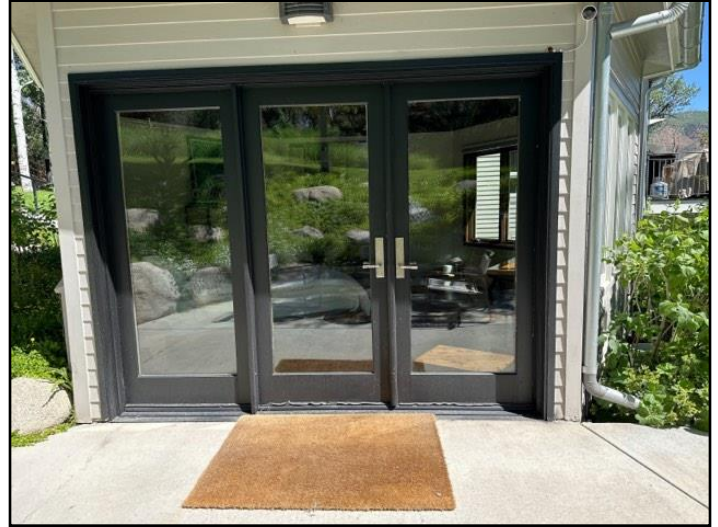
14. Condition: • [Many of the first floor doors have lever type handles. In areas where bears live it is strongly advised to have round exterior exterior door knobs/handles.](#)

Many of the first floor doors have lever...

Task: Replace
Time: Discretionary

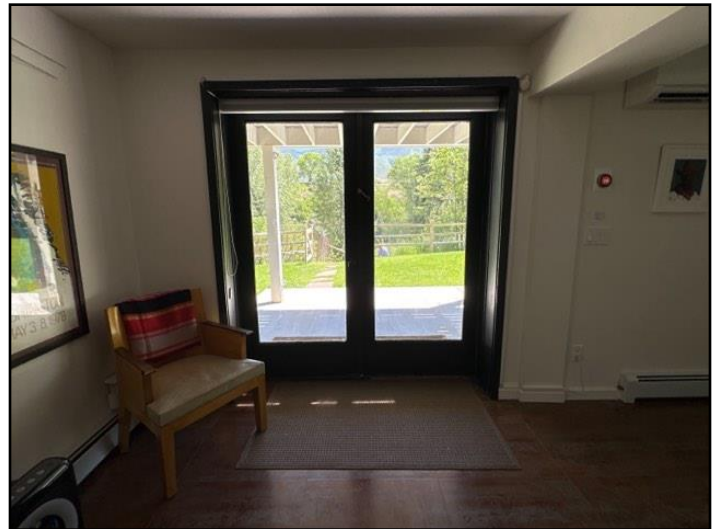
15. **Condition:** • [Lost seal](#)

Lost seal

Task: Repair or replace

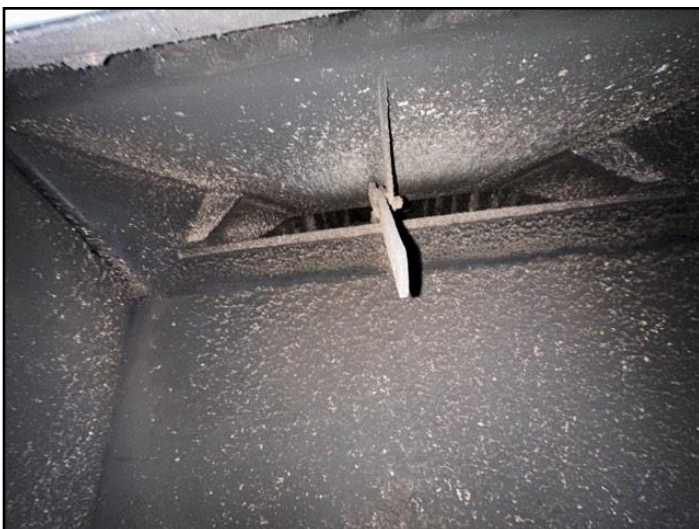
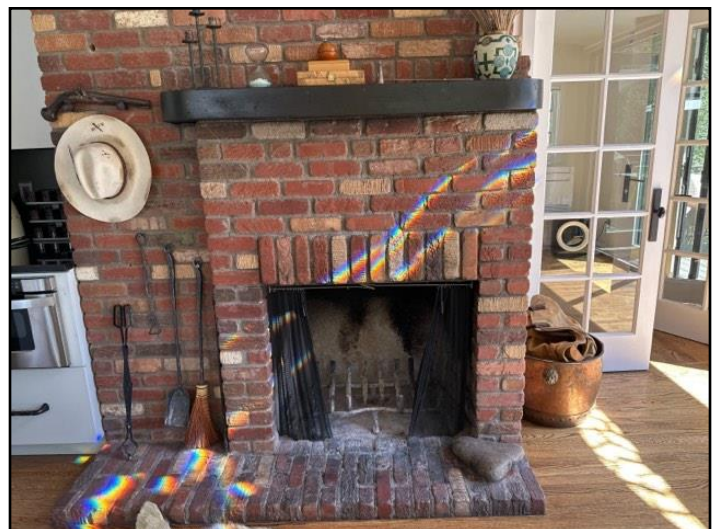
Creosote build-up

Task: Clean

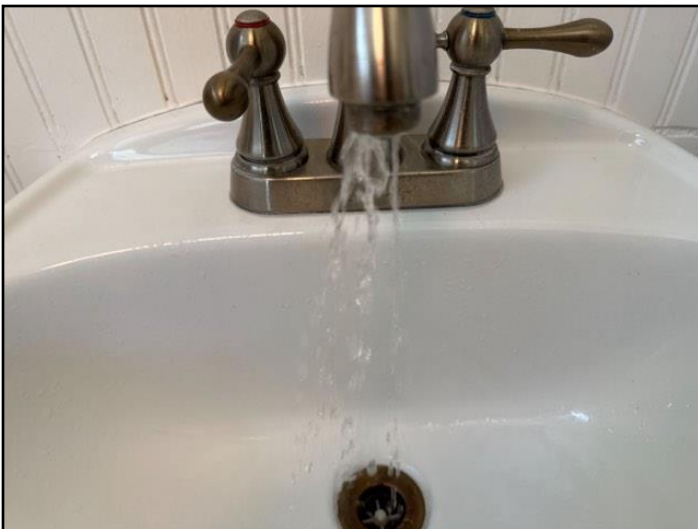
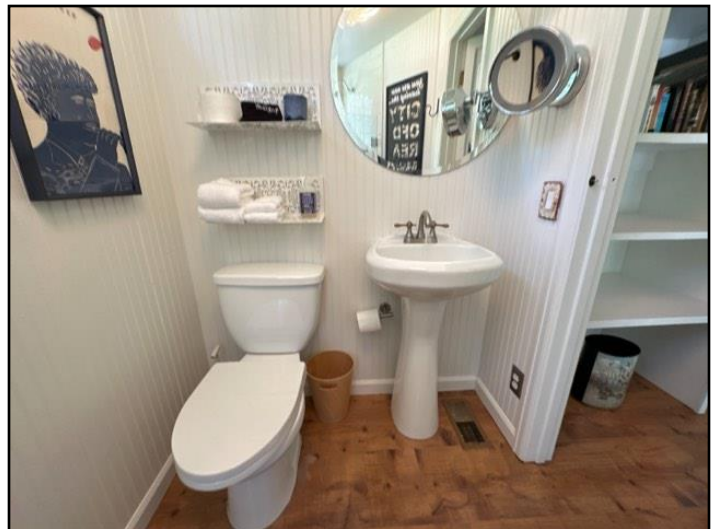
Aerator obstructed

Task: Clean

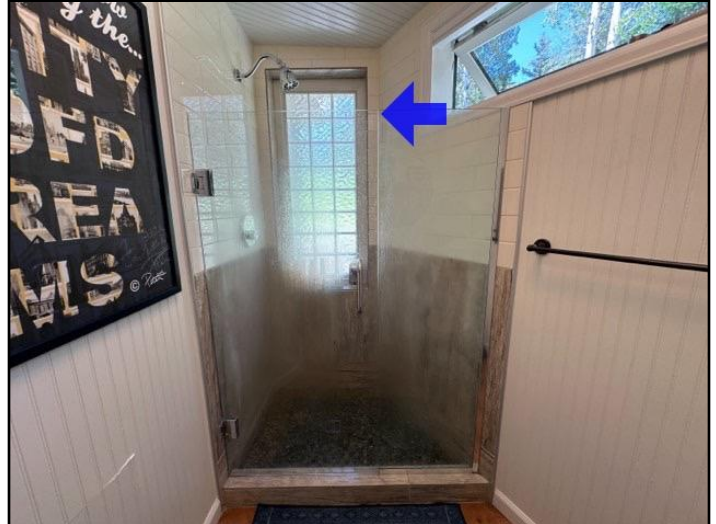
38. Condition: • [Entrance problems](#)

Entrance problems

Task: Repair

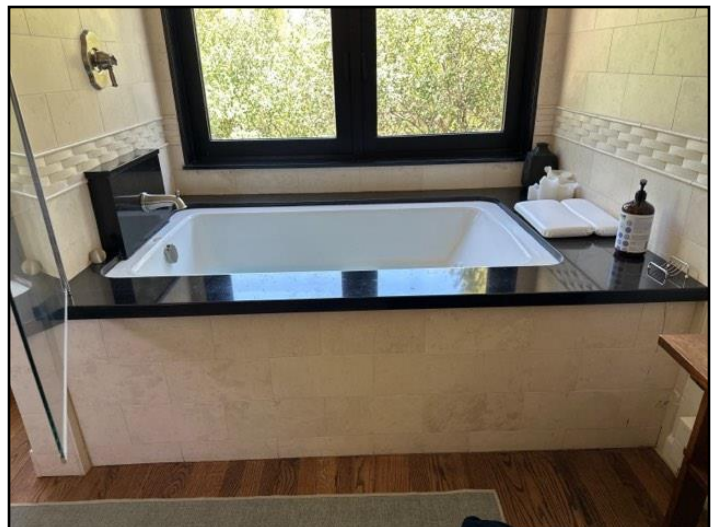
39. Condition: • [Inoperative](#)

Jets did not turn on when button was pressed. Home owner stated tile needs to be removed to repair.

Implication(s): Equipment failure

Inoperative

Task: Repair

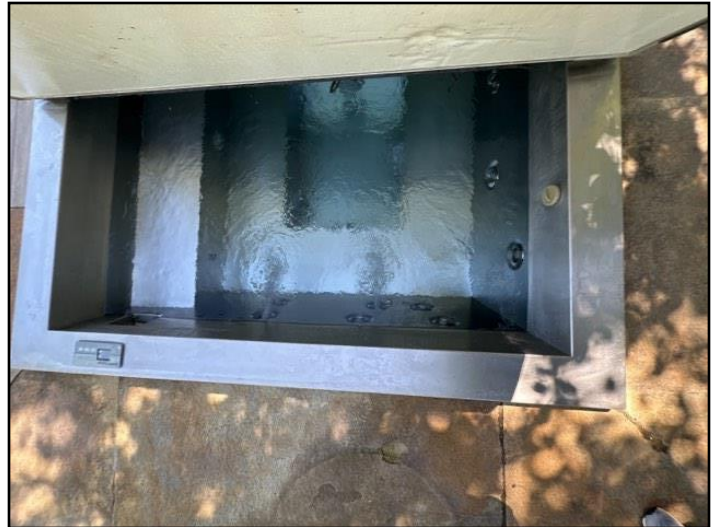
41. Condition: • Swimming Pools, Spas, Hot Tubs and Equipment are discussed in the information that follows. Hot tub was being serviced/repared at time of inspection. Recommend consulting with home owners

Being serviced

Task: Repair

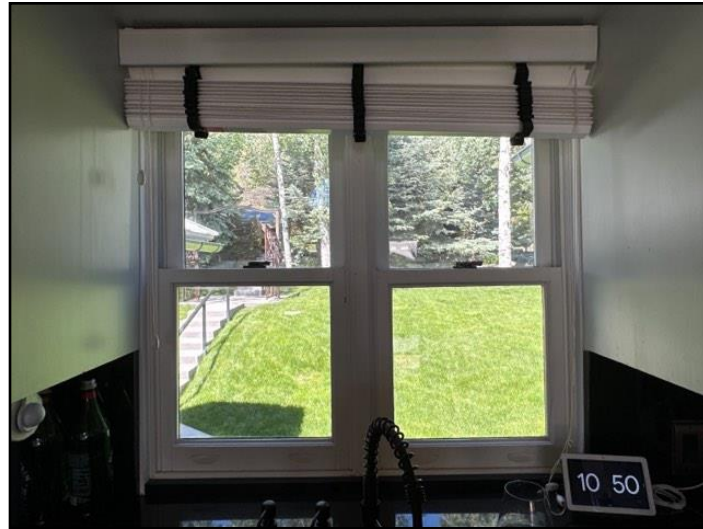
45. Condition: • Painted shut

Painted shut

Task: Improve

Time: As soon as practical

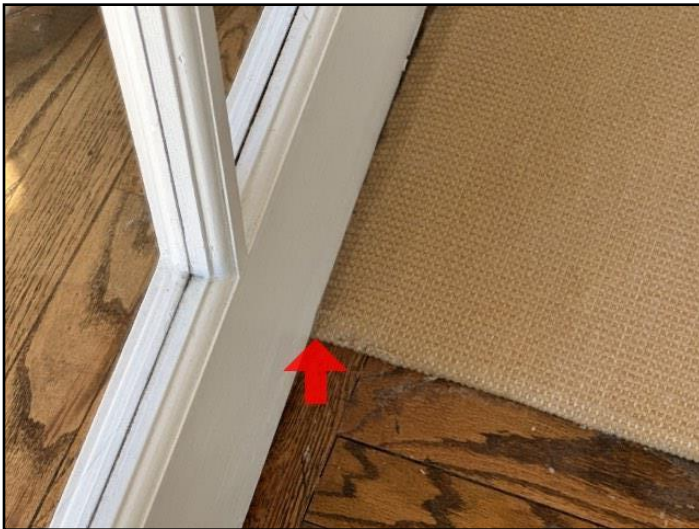
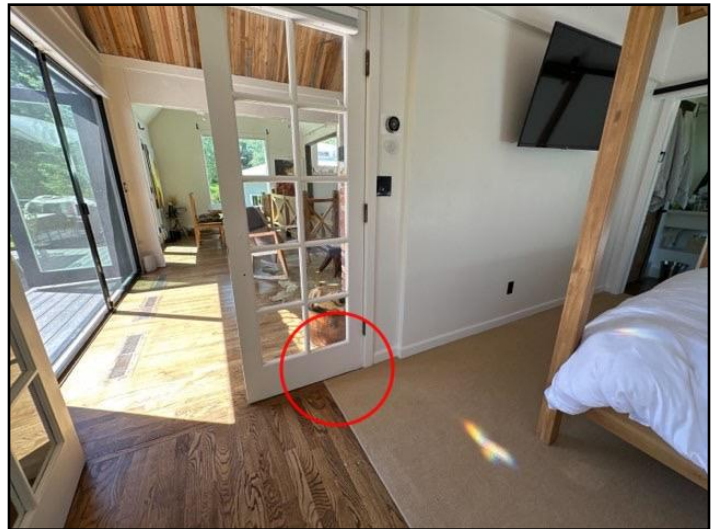
49. Condition: • Binds

Binds

Task: Improve

Time: Discretionary

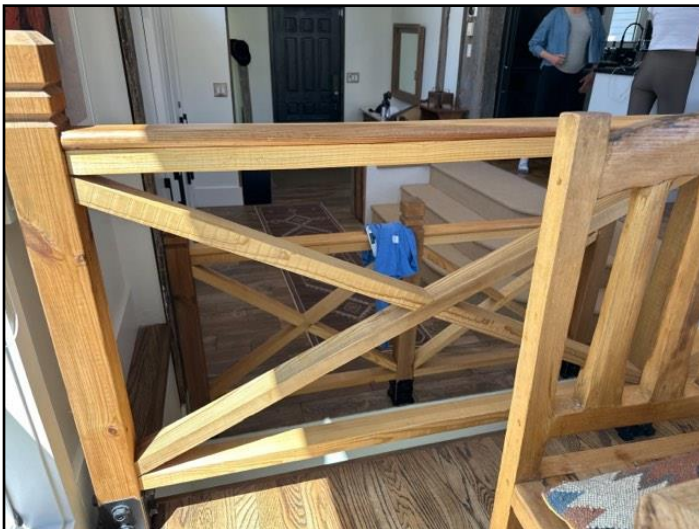
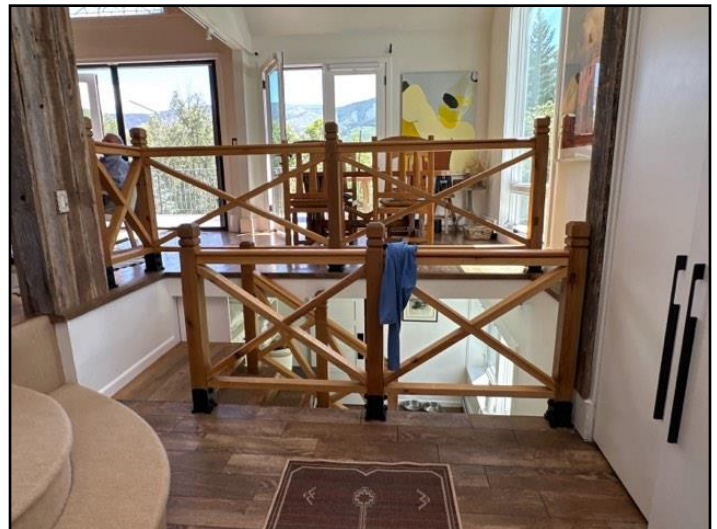
50. Condition: • [Too far apart](#)

Implication(s): Fall hazard

Too far apart

Time: As soon as practical
